REPORT ON TESTING OF FINAL COAT MODULE

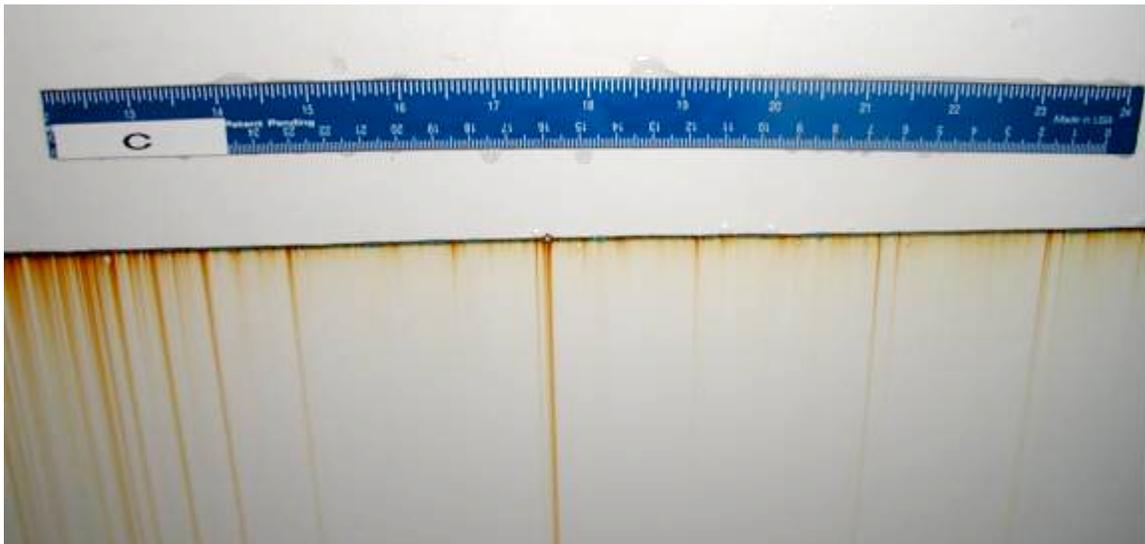
The difference in corrosion potential is also supported by the difference in the rust staining characteristics of the Test Panel, when compared with the Control Panel. Photographs of the two sets of panels are shown below in Figures 7 and 8. These tests showed marked differences in the extent of rust staining from the scribes on the Test Panel and the Control Panel from very short times.

Figure 8. Control panel appearance (Experiment One)

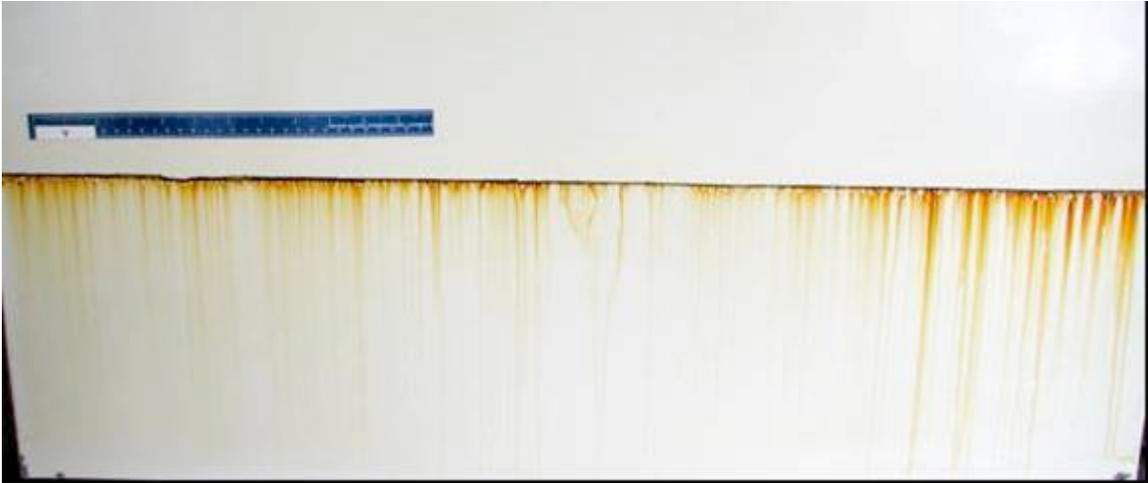
Figure 10 - Test panel appearance (Experiment Two)

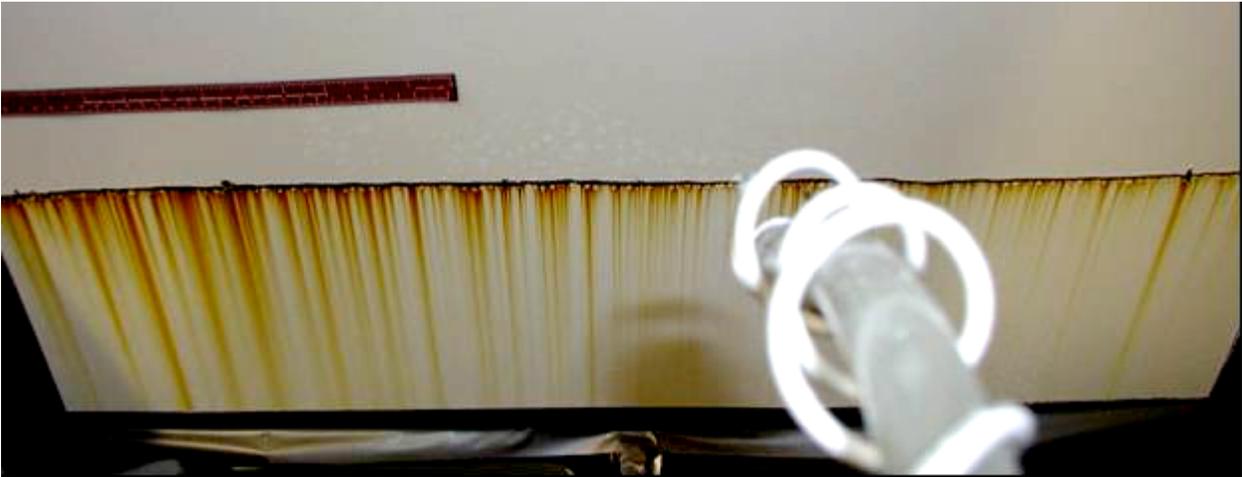
Figure 13 - Test panel appearance (Experiment Three)

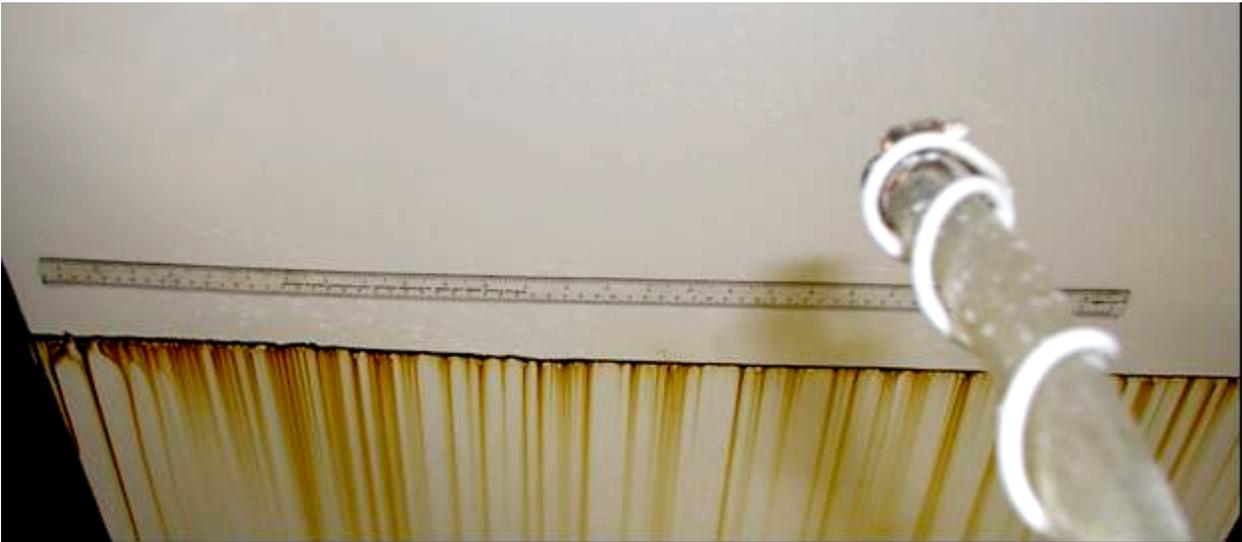
Figure 14 - Control panel appearance (Experiment Three)
